# BUZZ/RATTLE FROM DOOR PANEL WHEN OPERATING AUDIO SYSTEM—VEHICLES BUILT BEFORE 8/2/2007

TSB 07-17-6

**FORD:**  
2005-2008 Mustang

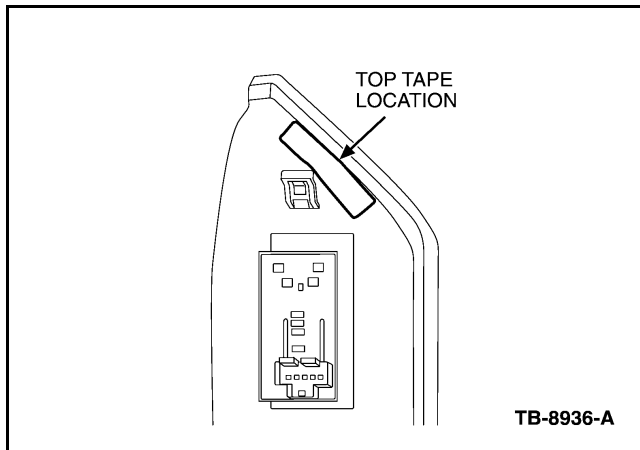
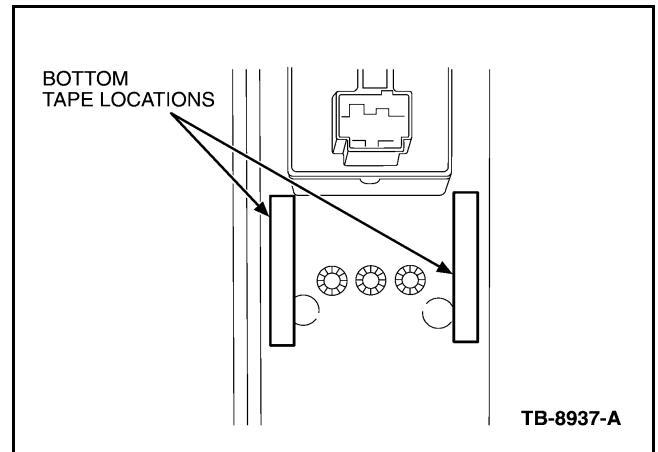
Some 2005-2008 Mustang vehicles built before 8/2/2007 may experience a buzz/rattle from the door panels when using the radio/CD player at elevated volumes or bass levels or voice broadcasts. This may be due to the window switch bezel vibrating against the door trim panel. This can often be incorrectly diagnosed as an audio speaker buzz or a bad speaker.

1. Remove window switch bezel from door panel and separate the two piece bezel.
2. Install three (3) pieces of PVC soft foam tape 3/8" wide by 1 3/4" long (10 mm by 45 mm) part number 164-R4901 from the Rotunda Squeak and Rattle Repair Kit part number 164-R4900. (Figures 1 and 2)
