FRONT SUSPENSION POPPING NOISE WHILE TURNING RIGHT OR LEFT—VEHICLES BUILT BEFORE 4/8/2005

TSB 07-18-1

FORD:
2005 Mustang

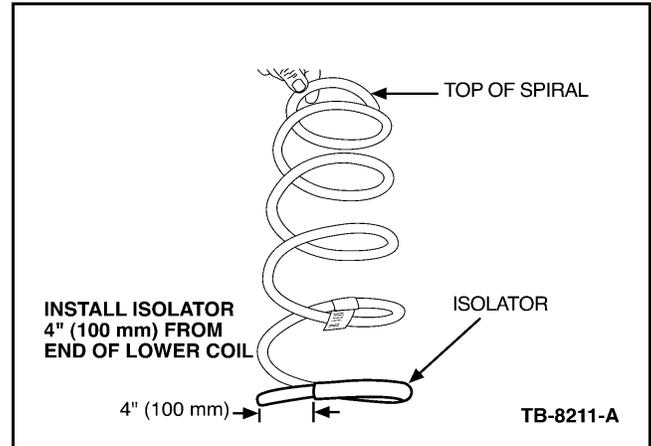
Figure 1 - Article 07-18-1

Some 2005 Mustang vehicles built before 4/8/2005 may exhibit an intermittent popping noise from the front of the vehicle while turning left or right. The noise will typically occur during low speed maneuvers and may occur multiple times while turning.

1. Remove the strut and spring assembly. Refer to Workshop Manual Section 204-01.
2. Disassemble the strut and spring assembly.
3. If the springs do not have a rubber isolator on the bottom spring coil, install isolators. Clean off any dirt prior to installing the isolator. The isolator should be installed 4" (100 mm) from the end of the coil (Figure 1).
