# INOPERATIVE RKE TRANSMITTER (KEY FOB)— DISCHARGED KEY FOB BATTERY

TSB 08-12-9

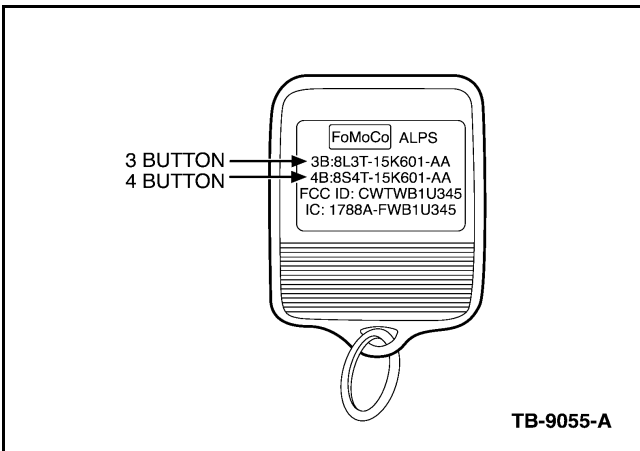
Figure 2 - Article 08-12-9

- a. If the vehicle was built within the date range, then continue with this procedure.
  - b. If not, then do not proceed. Continue with normal diagnostics per WSM, Section 501-14.
2. Is the vehicle Key Fob part number 8L3T-15K601-AA (3 button) or 8S4T-15K601-AA (4 button)? (Figure 2)
- a. Yes - Go to Step 3.
  - b. No - Do not proceed. Continue with normal diagnostics per WSM, Section 501-14.
3. Using a thin coin, open the Key Fob and inspect manufacturer's date code sticker. The first three digits = day of year. The last digit = year. (Figure 3)
