**FORD:**

2005-2009 Mustang

**ISSUE**

## TSB 08-26-7 (Continued)

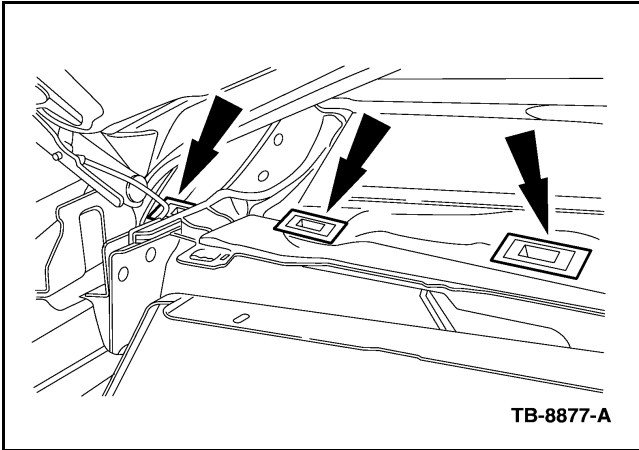
Figure 1 - Article 08-26-7

1. Verify that the plastic cowl panel grill is evenly seated against the windshield and not warped. If warped, replace with current service stock.
2. Remove the cowl panel grill. Refer to Workshop Manual (WSM), Section 501-02, and inspect for proper cowl panel mount grommet installation and pinch weld sealing. Water may enter the cowl channel, through the cowl panel grommets / seals or forward pinch weld, potentially causing a sloshing sound and/or water leaking down the dash kick panel area. If there is standing water in the cowl channel, remove by siphoning through a cowl panel mount grommet hole. (Figures 7-8 - end of article)
3. Verify that the ten (10) cowl panel mount grommets and seals are installed and sealing tightly to the vehicle. If any are missing, or the seals are damaged, replace as necessary. (Figure 1)

- a. Remove old cowl grommets and clean entire cowl surface with a suitable wax and grease remover. If silicone and/or seam sealer was used to seal grommets, ensure all sealer is removed before installing new grommets.
- b. With surface clean and prepped, snap the hot melt cowl grommet into cowl panel.
- c. Using a suitable heat gun, heat the hot melt cowl grommet until the hot melt material begins to squeeze out from under the plastic grommet. Do not over heat the grommet because deformation of the plastic grommet may occur.
- d. After heating the grommets, a light amount of pressure may be applied to the outer perimeter of the grommet to help sealing.
- e. Do not over heat around windshield or fender edges or damage may result.

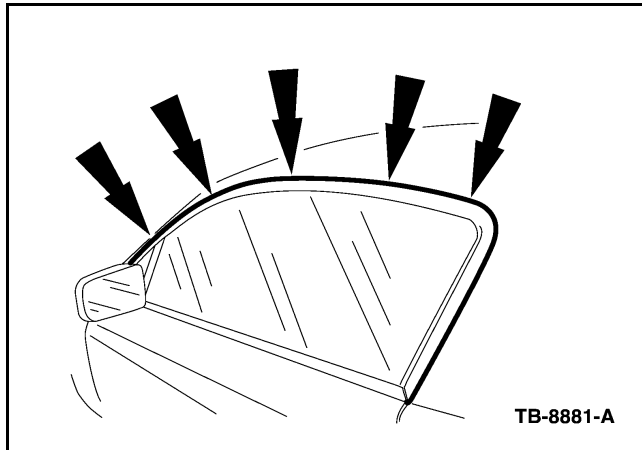
Figure 5 - Article 08-26-7

7. Remove and inspect the foam seal of window weatherstrip retainer at the A-pillar. Tears in the foam seal may allow water to enter the vehicle, between window weatherstrip retainer and the A-Pillar, and travel inside the interior A-Pillar trim molding into the dash kick panel area. (Figure 5)

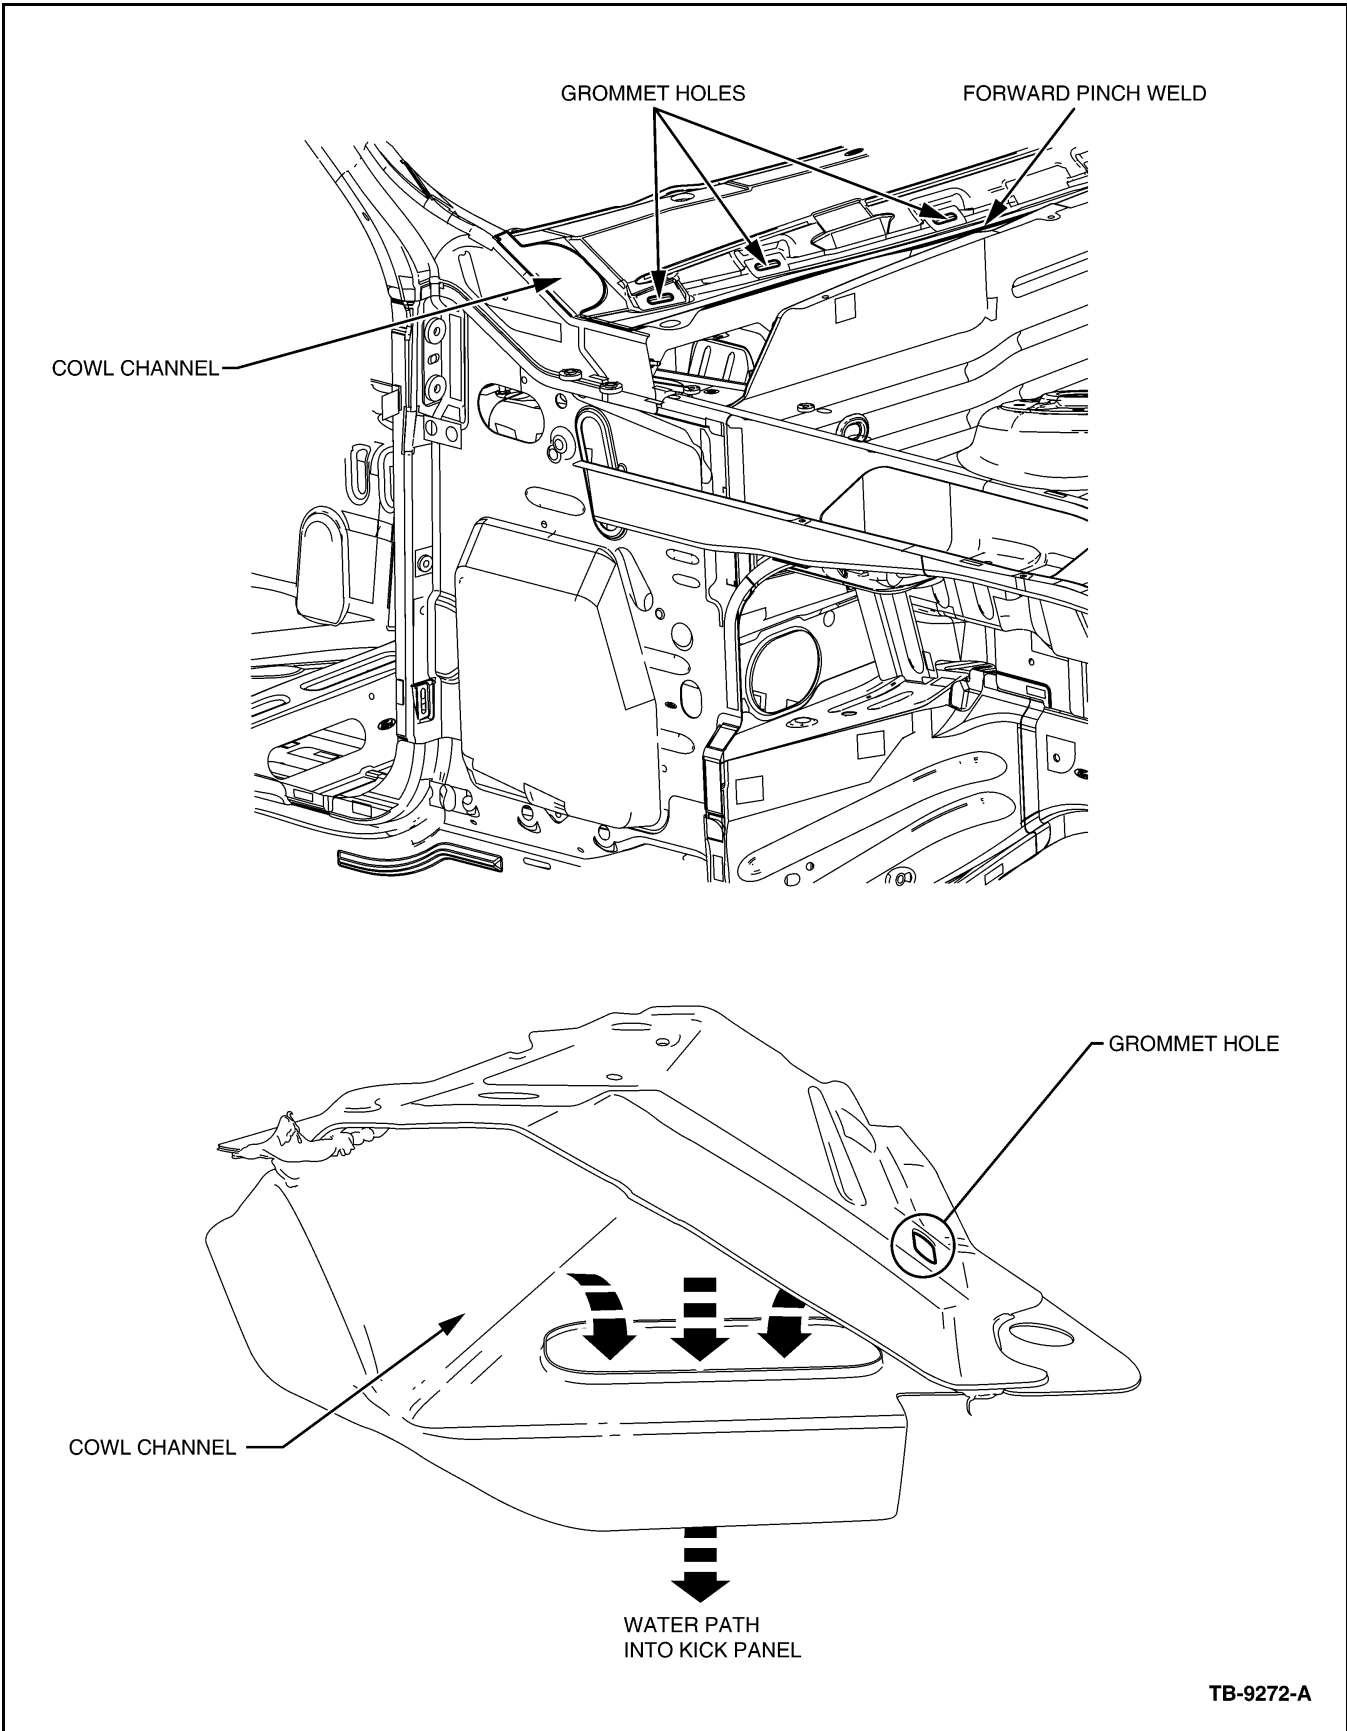
Figure 7 - Article 08-26-7

DO NOT REMOVE COWL GROMMETS DURING WATER TESTING. (FIGURE 7 AT END OF ARTICLE)

**WATER PATHS INTO FRONT FLOOR KICK PANEL AREAS**  
(DASH AND DASH INSULATOR REMOVED FOR ILLUSTRATION PURPOSES)
