5R55S/5R55N/5R55W TRANSMISSIONS—SHIFT CONCERNS, LOSS OF 2ND, 3RD AND 5TH GEAR, INCORRECT RATIO DTC'S—PROCEDURE TO INSPECT AND REPAIR SERVO PIN BORE WEAR

TSB 09-12-12

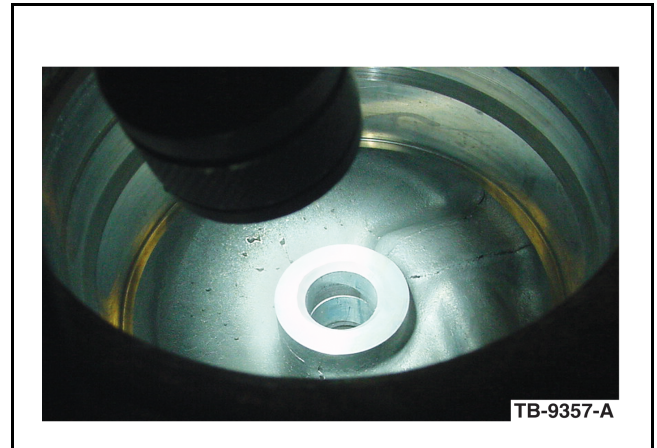
Figure 1 - Article 09-12-12

For transmissions that have been determined to require an overhaul or rebuild and the overdrive band or intermediate band have excessive wear or burned/damaged band friction material, the cause maybe excessive servo pin case bore wear generally found on higher mileage vehicles, usually accompanied with incorrect ratio diagnostic trouble codes (DTCs), condition becomes worse when hot. (Figure 1)

Inspect and repair the worn-damaged transmission case servo pin bore utilizing the Rotunda Tool 5RW Master Kit part number NRL5RW servo pin bore repair system (1-800-768-8632 option 6).
