FORD:
2005-2010 Mustang

TSB 09-18-16 (Continued)

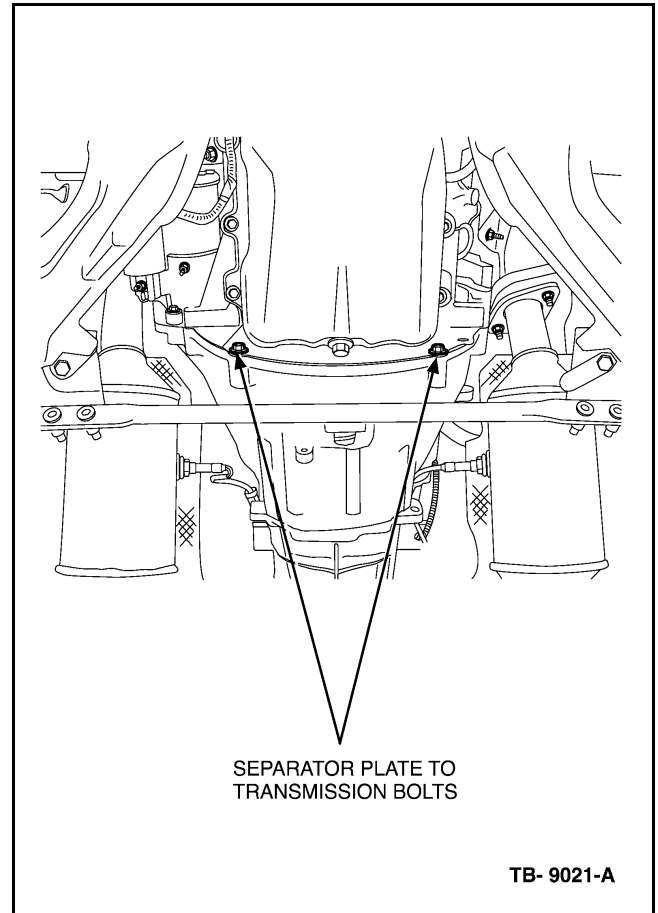
Figure 1 - Article 09-18-16

INSTALL NEW SEPARATOR PLATE TO TRANSMISSION BOLTS IF MISSING OR DAMAGED. (FIGURE 1)

1. Remove transmission per Workshop Manual (WSM), Section 308-03B.
2. Pry separator plate from the rear face of the block alignment dowels and slide it out from between block and flywheel. Replace with new service part.
3. Install transmission per WSM, Section 308-03B.
