FORD:
2005-2010 Mustang

Some 2005-2010 Mustang vehicles equipped with a convertible top may exhibit a headliner that pulls away from the number 1 bow.

TSB 10-4-13 (Continued)

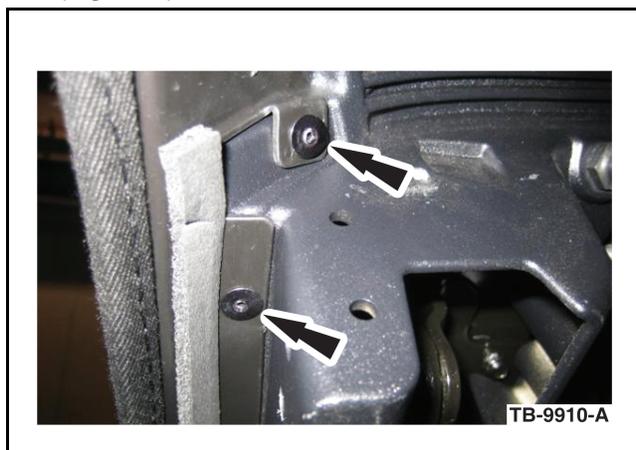
Figure 1 - Article 10-4-13

1. The convertible top will need to be opened to the 3/4 position to perform the following repairs.
2. Remove the RH/LH front weatherstrip retainer channel. Refer to Workshop Manual (WSM), Section 501-18 Convertible Top - Exploded View.
3. Remove front compression panel. Refer to WSM Section 501-18.
4. Remove the RH/LH staples from the number 1 bow.
5. Two (2) pop rivets are located on each side of the top cover to the number 1 bow and will need to be removed by drilling out the rivets. (Figure 1)

- a. The two (2) pieces of double sided sticky tape present in the number 1 bow groove can be reused.
10. Remove the remainder of the drilled out rivets from Step 4.
11. Reinstall the two header bow listings to the number 1 bow.
12. Install the header form panel. Make sure that the center headliner cloth tab is secured between the number 1 bow and header form panel securing it with the rear screw. Install the short screw in the forward/center position. Torque header screws to 44 lb-in (5 N•m).
13. Prior to pulling the top cover over the header form panel apply a light mist of water over the double sided sticky tape on the header form panel. This will allow the top cover enough movement for securing before the tape bonds to the top cover.
14. Pull the top cover over the header form panel and install the top cover rivets to the number 1 bow (2 each side). (Figure 1)

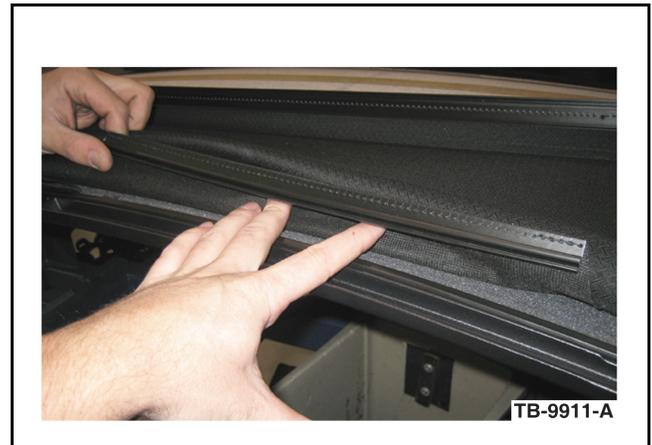
Figure 2 - Article 10-4-13

6. Fold the front of the top cover back exposing the header form panel.
7. Remove the six (6) screws retaining the header form panel to the number 1 bow.
 - a. Short screw is located in the front center location.
8. Detach the RH/LH header bow listings from the number 1 bow. Revealing the headliner attachment. (Figure 2)
