**5.0L ENGINE—METALLIC RATTLE OR SCRATCHING
TYPE NOISE FROM FRONT OF LEFT HAND
CYLINDER HEAD AT IDLE—BUILT ON OR BEFORE
3/31/2011**

TSB 11-9-15

FORD:
2011 Mustang

2012 Mustang
2011 F-150

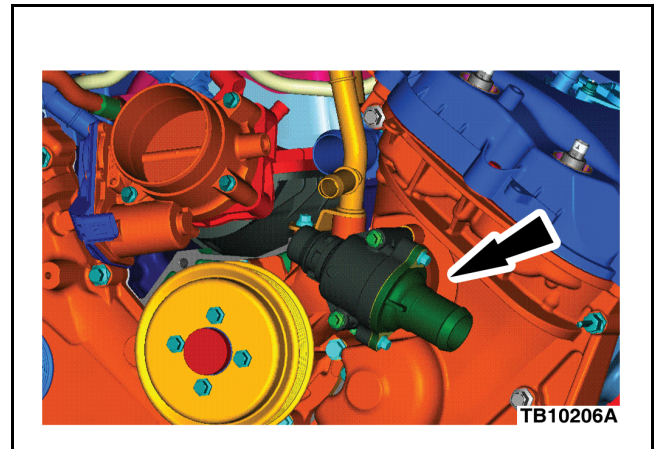
Figure 1 - Article 11-9-15

1. With the vehicle in park, start the engine and operate at idle allowing the engine to warm to normal operating temperature.
2. Using a mechanic's stethoscope or EngineEAR, evaluate area at front of left hand (driver side) cylinder head for metallic rattle or scratching type noise. Stethoscope or EngineEAR probe should be placed in the areas shown. (Figures 1 and 2)
3. Is the noise heard in the areas shown? (Figures 1 and 2)

- a. Yes - Replace the left hand primary tensioner and the left hand timing chain tensioner arm using the kit part number provided in this article. Refer to Workshop Manual (WSM), Section 303-01C, Camshaft-Left Hand , for removal and installation procedure.

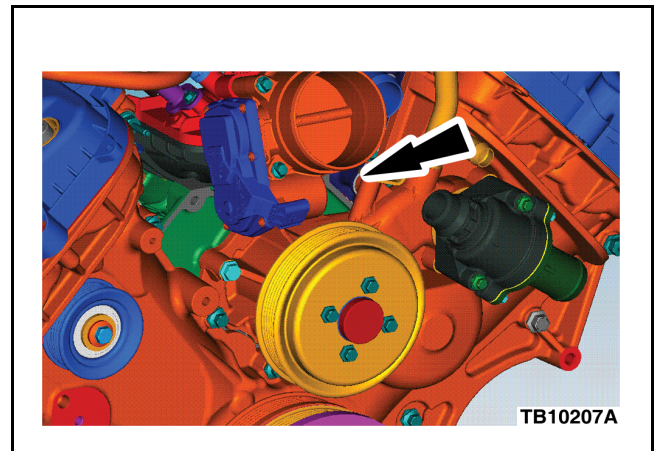
Figure 2 - Article 11-9-15

(Place stethoscope on cylinder head oil galley.)
