## **Installation Instructions: Door Lock Actuator**

(performed on a 1989 Mustang 5.0 LX Coupe)

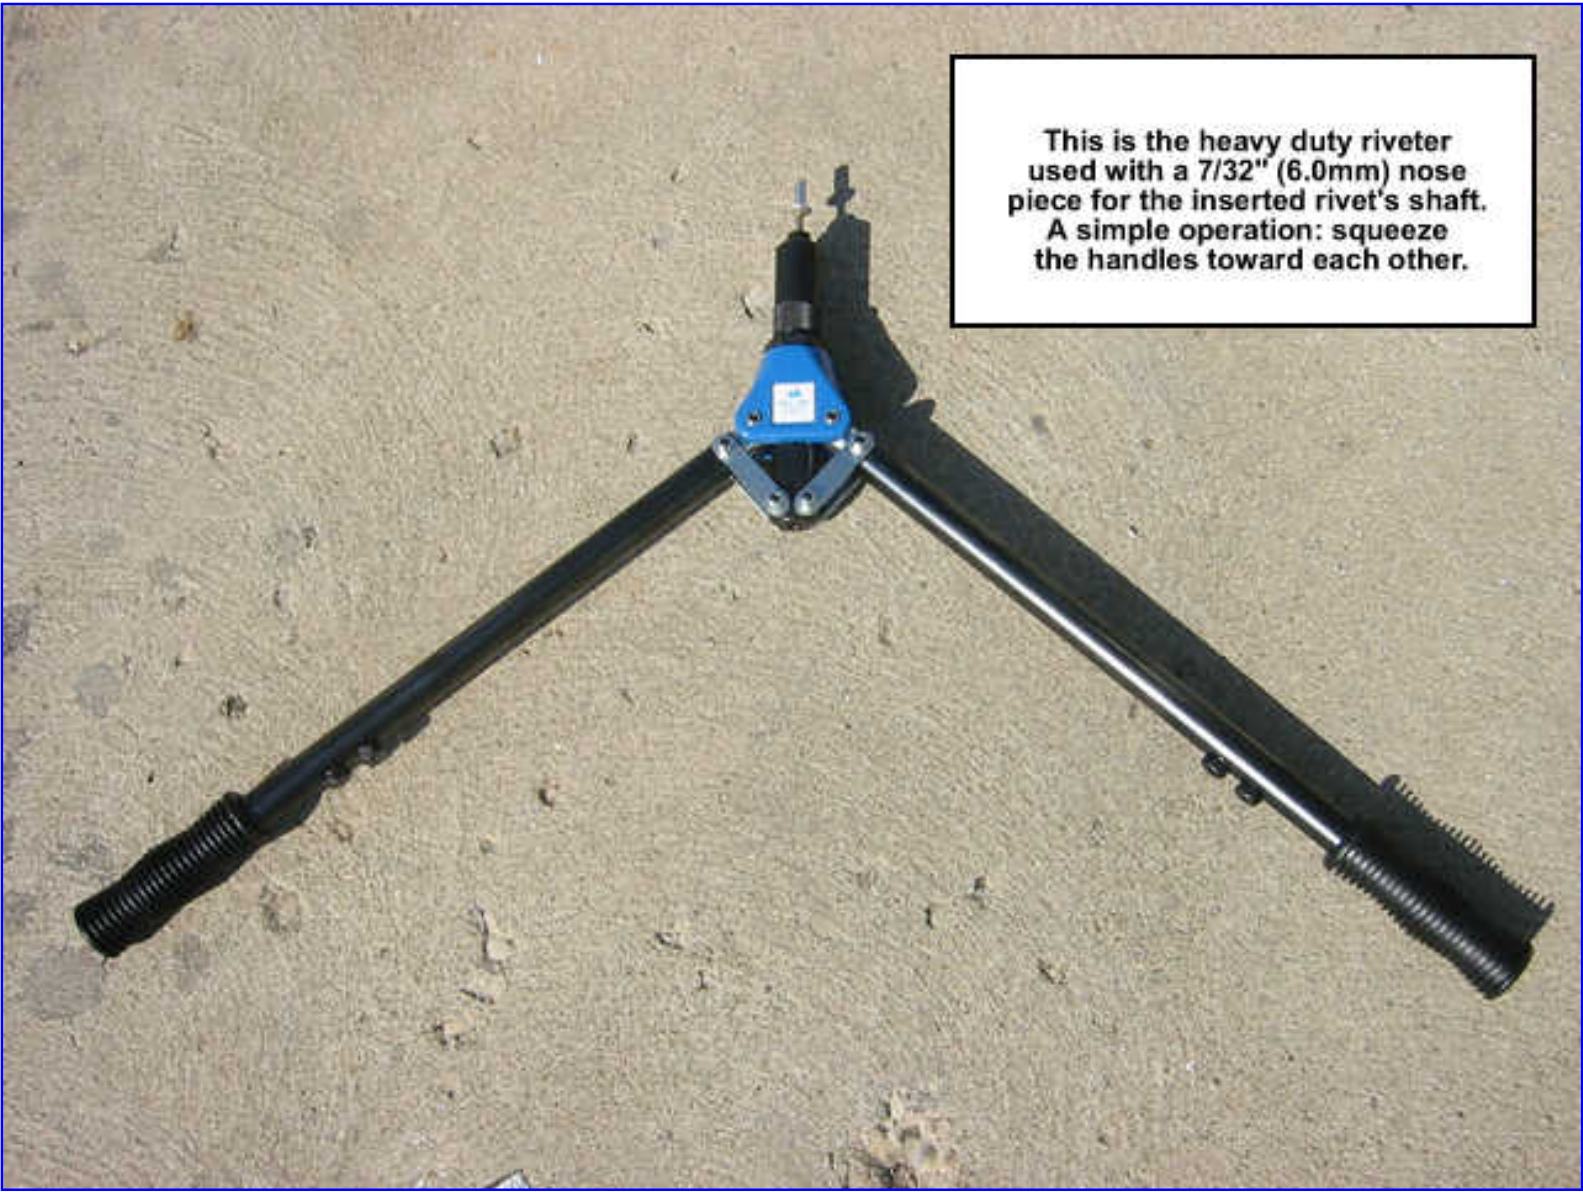
**This is the heavy duty riveter used with a 7/32" (6.0mm) nose piece for the inserted rivet's shaft. A simple operation: squeeze the handles toward each other.**
