**Installation Instructions: Door Panel Clips**  
(performed on a 1989 Mustang 5.0 LX Coupe)

*Latemodel Restoration Supply - 1979-2001 Mustang parts*

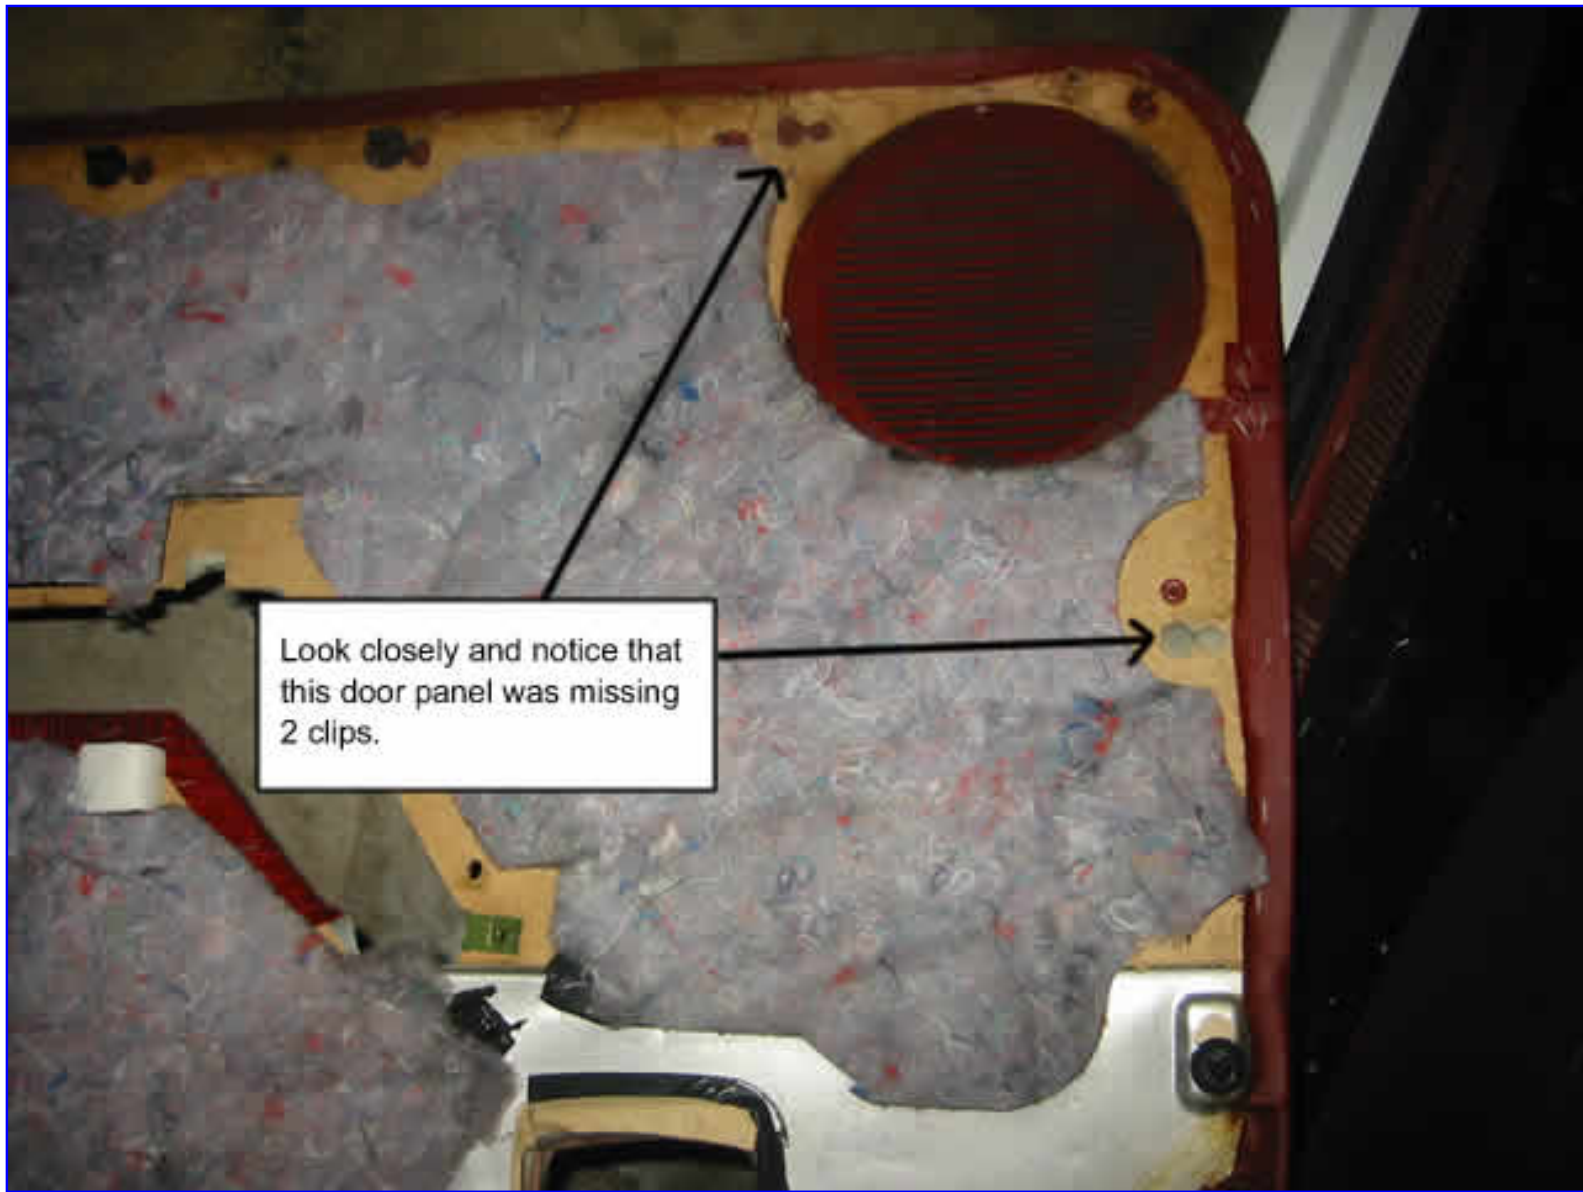
Look closely and notice that this door panel was missing 2 clips.

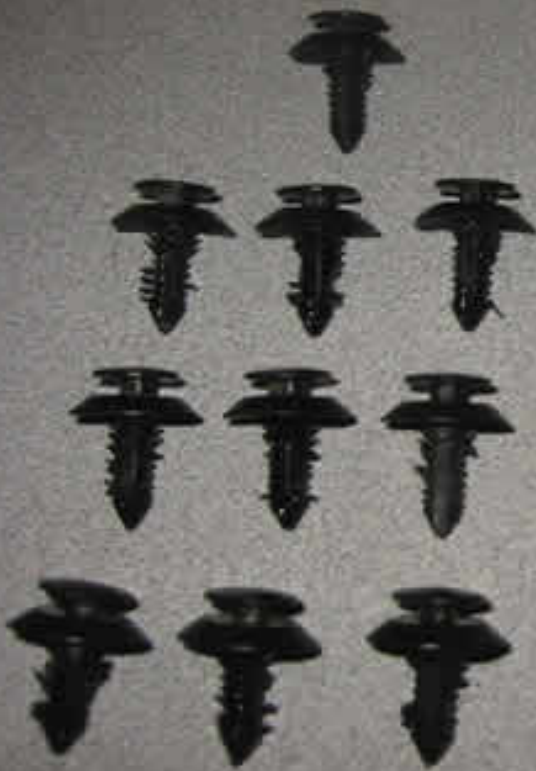
Here are the old door panel clips. Most do not have much gripping ability left.

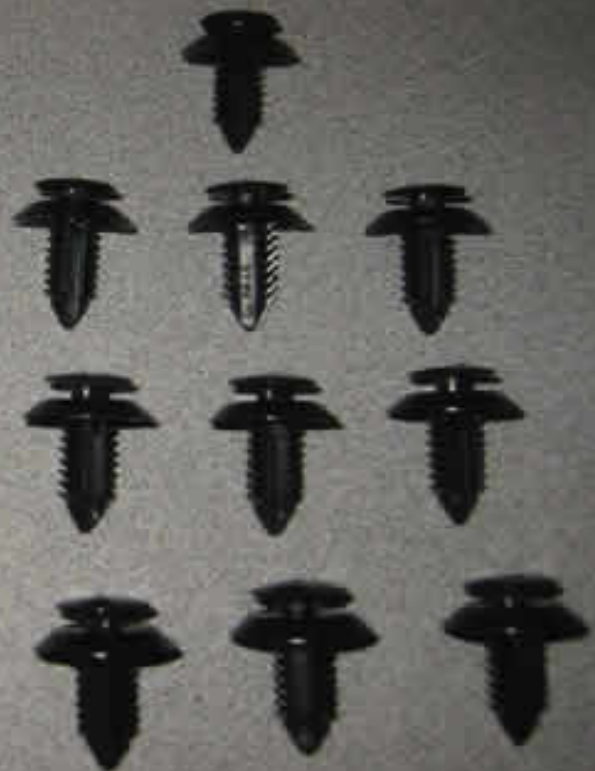
These new ones ensure the door panel attaches snug to the door for less rattle noise.

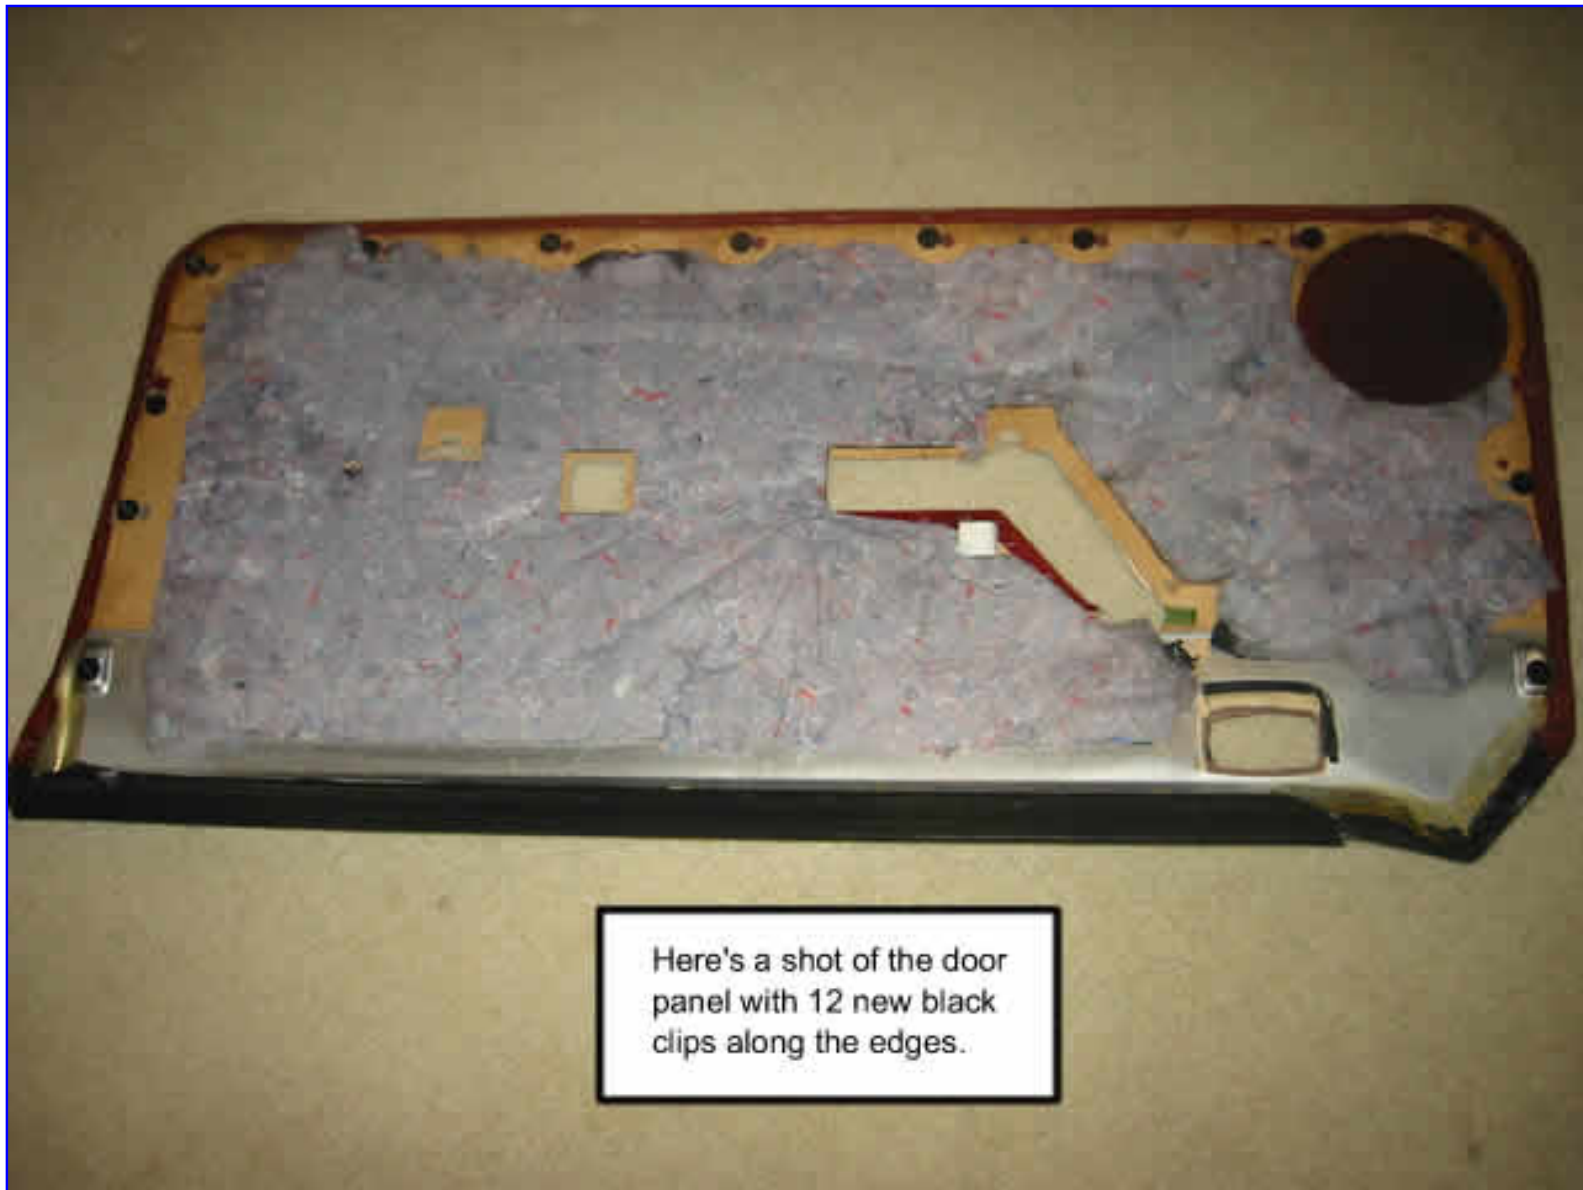
Here's a shot of the door panel with 12 new black clips along the edges.
