FORD:
2005-2007 Mustang

ISSUE

Some 2005-2007 Mustang vehicles may need to have the carpet replaced for various issues. The following procedure will allow the carpet to be removed and replaced without removing the heater / air conditioning plenum, instrument panel, or restraints control module (RCM).

TSB 06-26-2 (Continued)

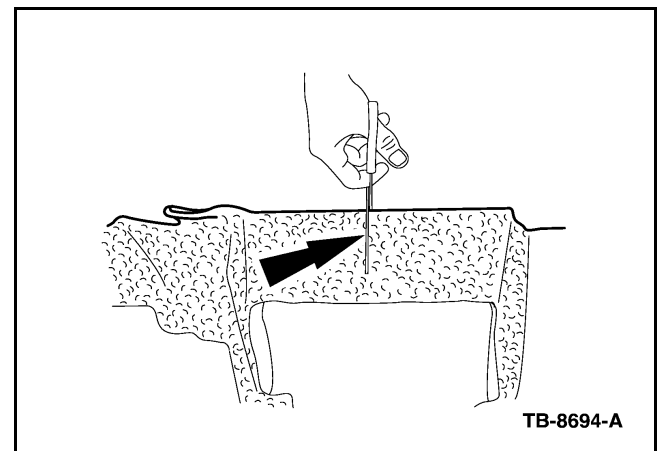
Figure 1 - Article 06-26-2

1. Using scissors, cut the new carpeting in the areas shown. (Figure 1 and Figure 2)

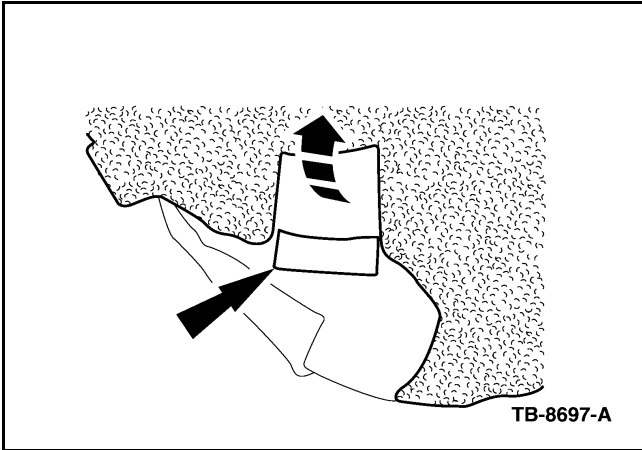
Figure 3 - Article 06-26-2

2. Clean the area using an alcohol swab or rag and then apply a thin layer of Motorcraft Trim and Weatherstrip Adhesive on the carpet backing. (Figure 3 and Figure 4) Allow to dry for 5 minutes.

3. Apply a 3" by 1" strip of self adhesive Velcro (both halves-obtain locally) to the areas shown. (Figures 3 and 4)

4. Install carpeting into vehicle.
5. Remove the protective cover from the Velcro strip and carefully insert the carpet under the RCM. Press the Velcro into place.
6. Remove the protective cover from the Velcro strip and carefully insert the carpet under the heater/air conditioning plenum assembly. Press the Velcro into place.
7. Reinstall the seat belts, interior trim, and seats per WSM 501-20A.
